SPECIAL FLOOD CONTROL REPORT

Los Angeles, San Gabriel, Santa Ana Rivers, California

FLOOD CONTROL  
FIELD COORDINATING COMMITTEES 18-20  
March 29, 1938

PHOTOGRAPHS

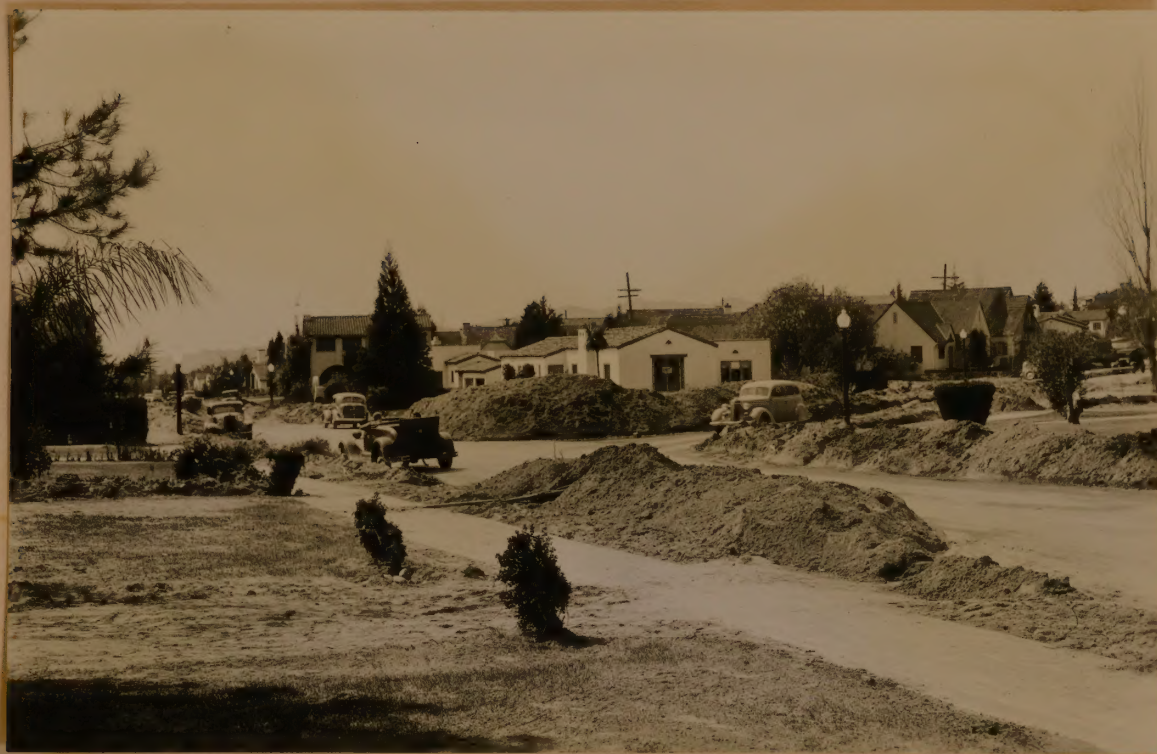
U.S.F.S. CHG-1415

- A. Silt-piled streets of beautiful Rossmoyne Village, Glendale, derived partially from area burned recently in nearby mountains.

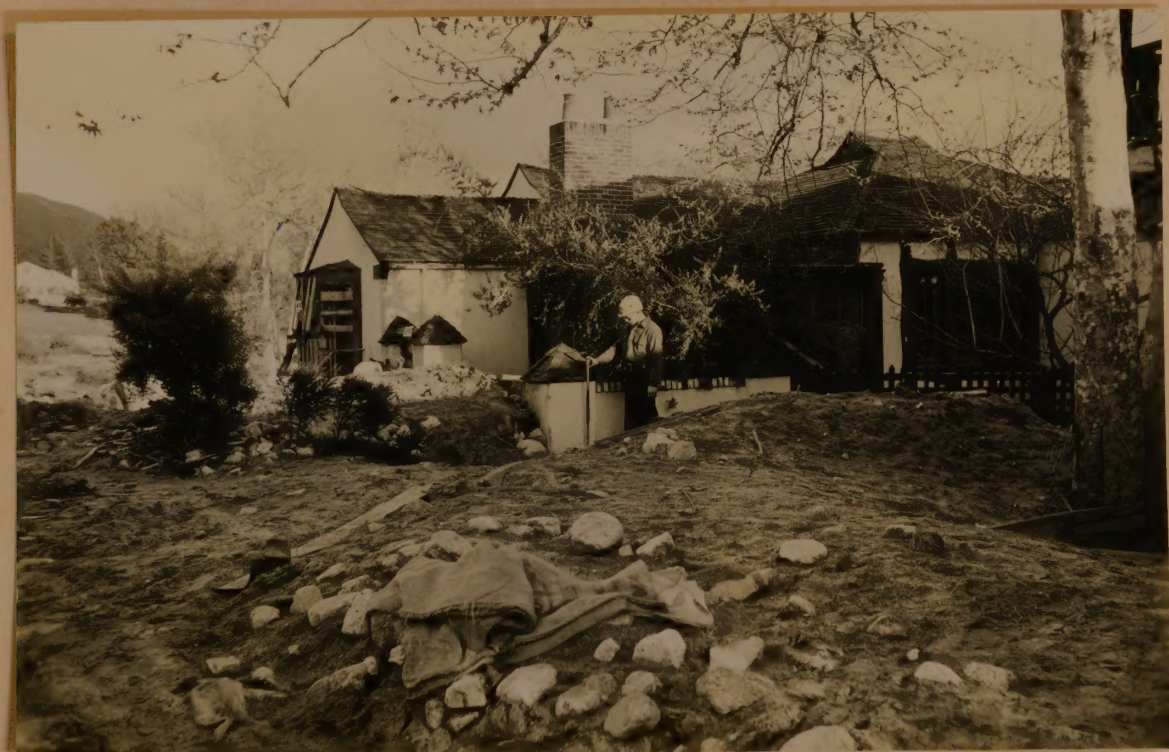
U.S.F.S. CHG-1454

- B. Homes of a highly restricted residential district in Altadena were severely damaged by overflow of debris basin below a burned area.

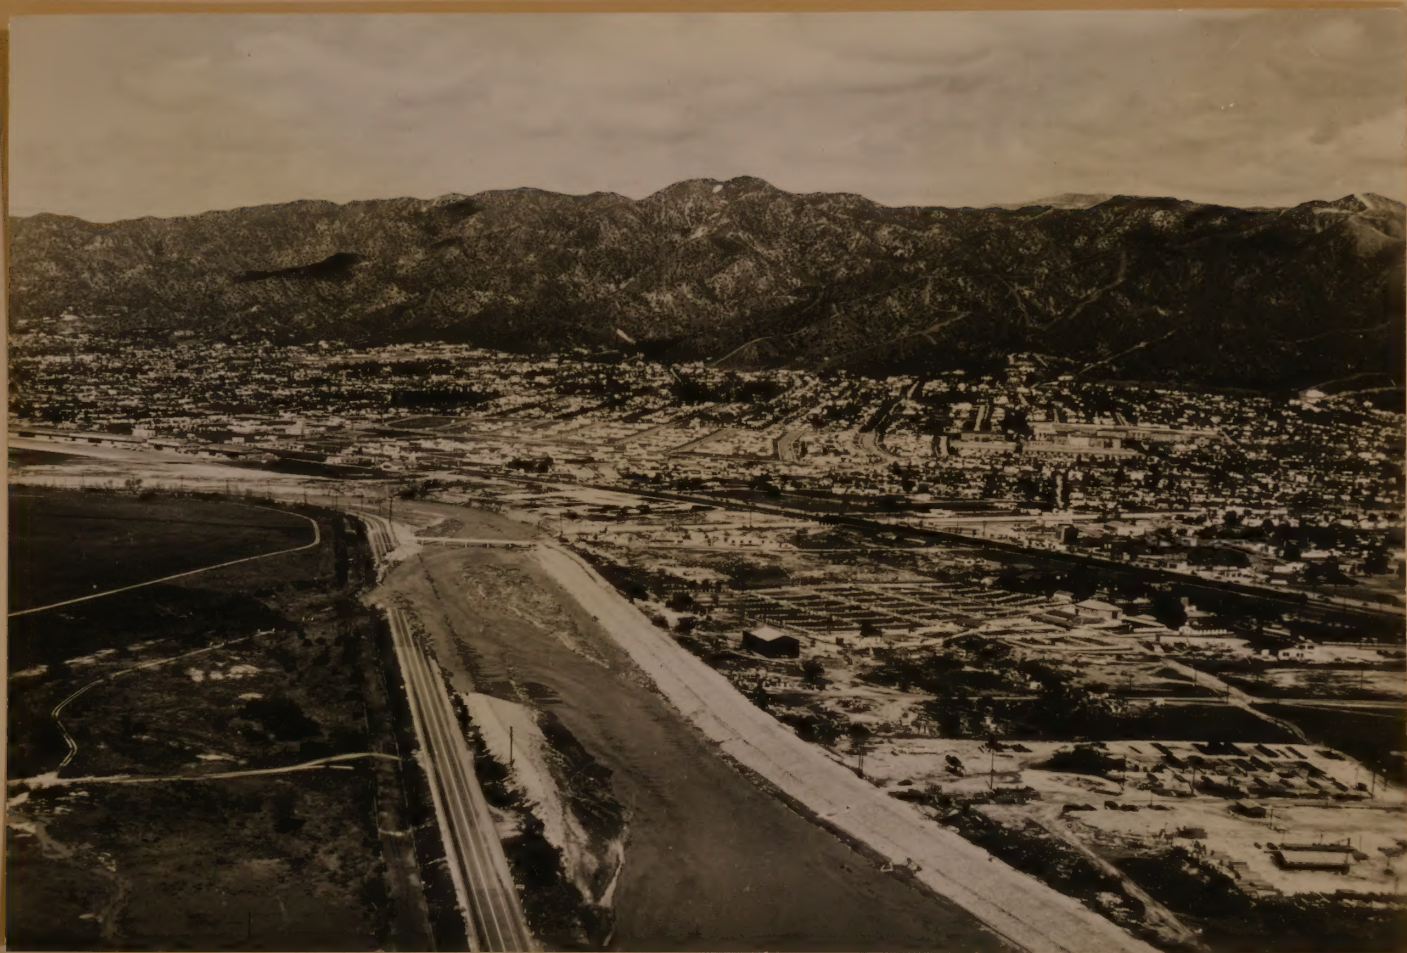
Cal. Nat. Gd. ( )

Rock-faced levees failed to restrain the Los Angeles River from meander cutting, with consequent destruction of U. S. Highway No. 99, below Glendale. Vegetative cover on Verdugo Mountains in center distance is still sparse after demudation by fire in 1927.

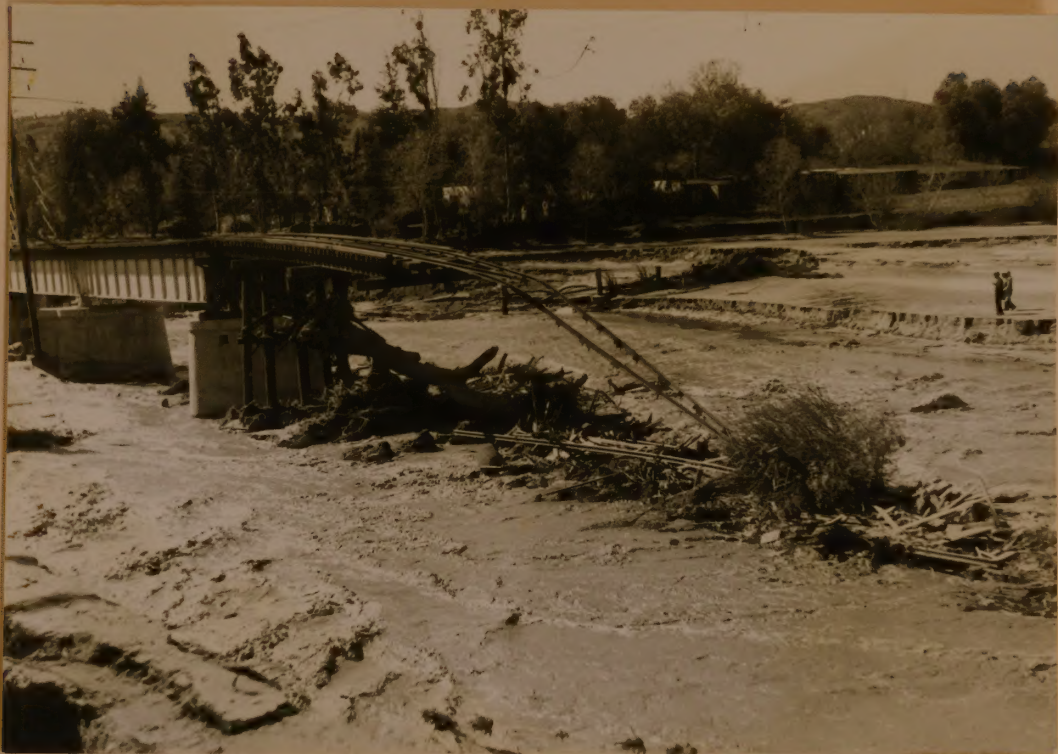
U.S.F.S. 82-H-1

- A. Vineland St. railroad bridge destroyed by flood waters of Big Tujunga Wash, North Hollywood.

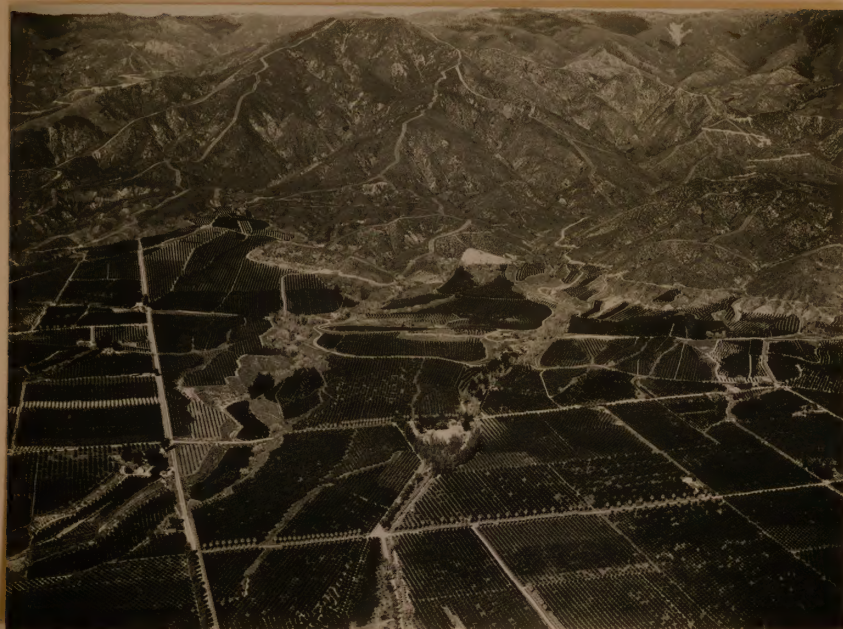
S.C.S. HMG-3

- A. Flood wash down old channels through highly developed foothill citrus belt near Redlands.

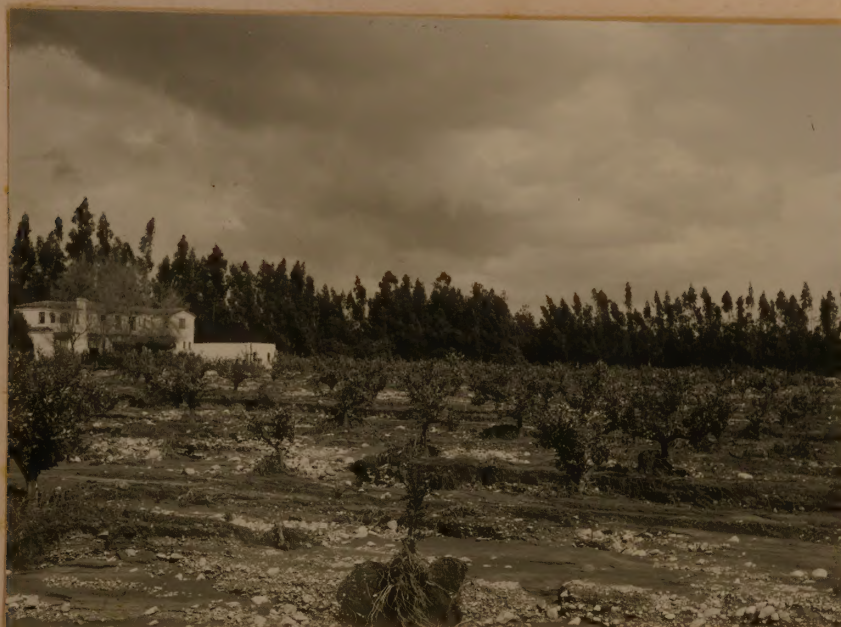
S.C.S. HMG-14

- B. Many highly developed properties were severely damaged by the sweeping rush of flood water, among which the above citrus grove near Cucamonga is an extreme but not unusual example.

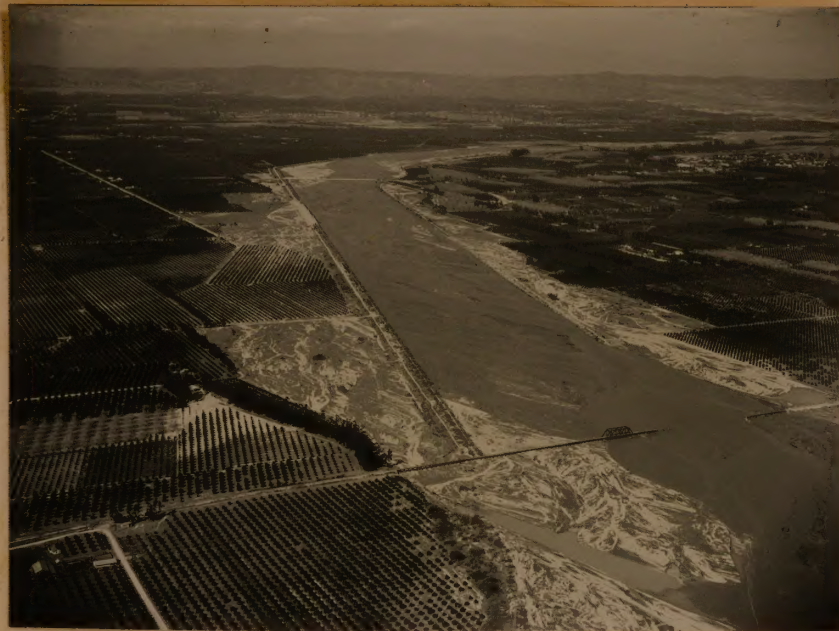
S.C.S. HNC-12

- A. Deposition on highly developed agricultural lands and silting of channel in the Santa Ana River near Anaheim.

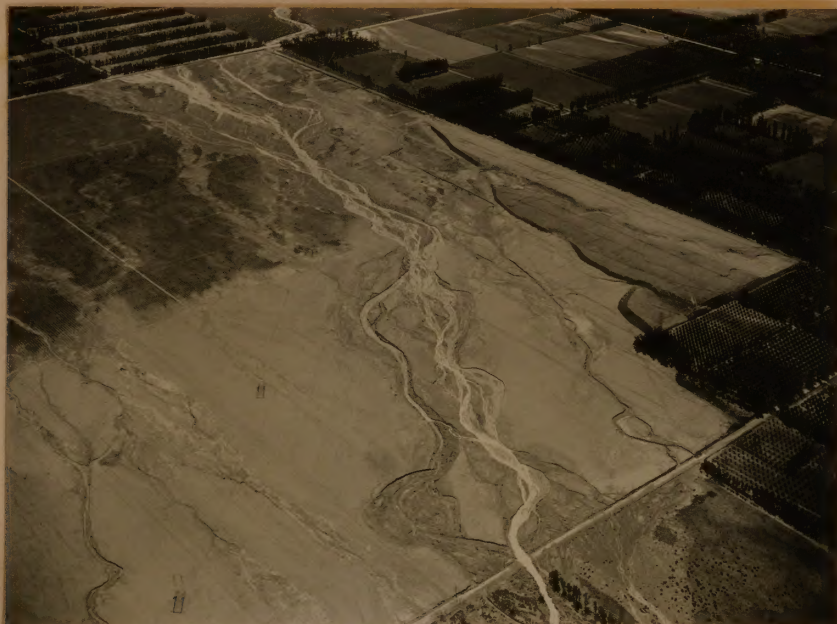
S. C. S. HNC-9

- B. Sweeping flood waters caused severe damage to vineyards and other valuable agricultural developments, such as this one lying eastward of Cucamonga.

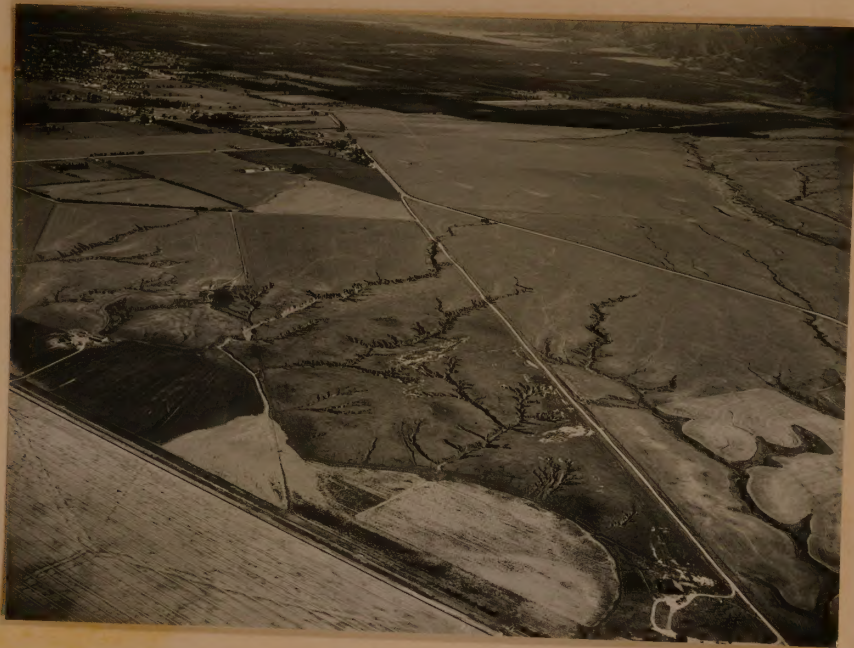
S.C.S. HMO-4

- A. Severe sheet and gully erosion on agricultural lands, near Beaumont, California, caused by runoff originating on fields themselves.

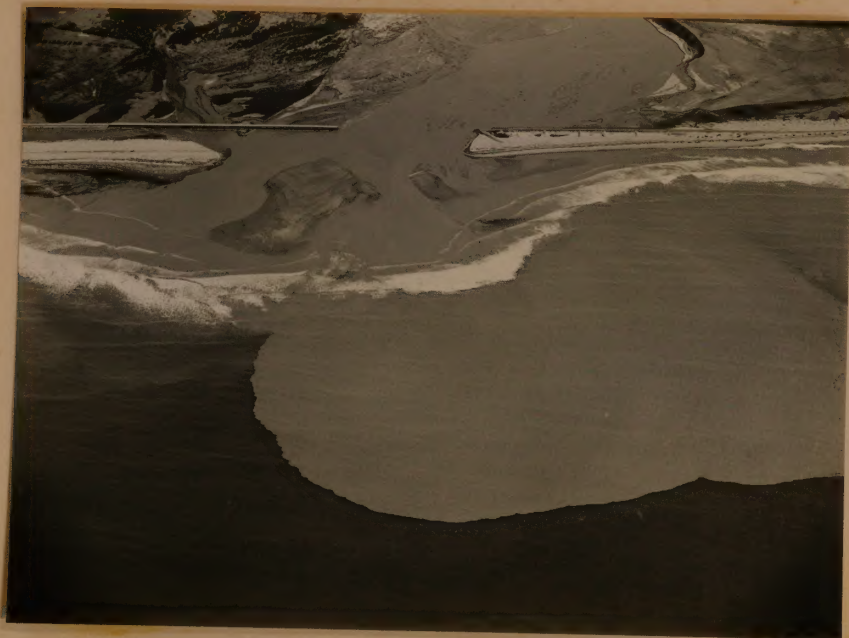
S.C.S. HMO-10

- B. Fine components of the eroded materials discharged into clear ocean waters by the muddy flood flow from Santa Clara River, characteristic also of the condition at mouths of Los Angeles, San Gabriel, Santa Ana, and other rivers in southern California.

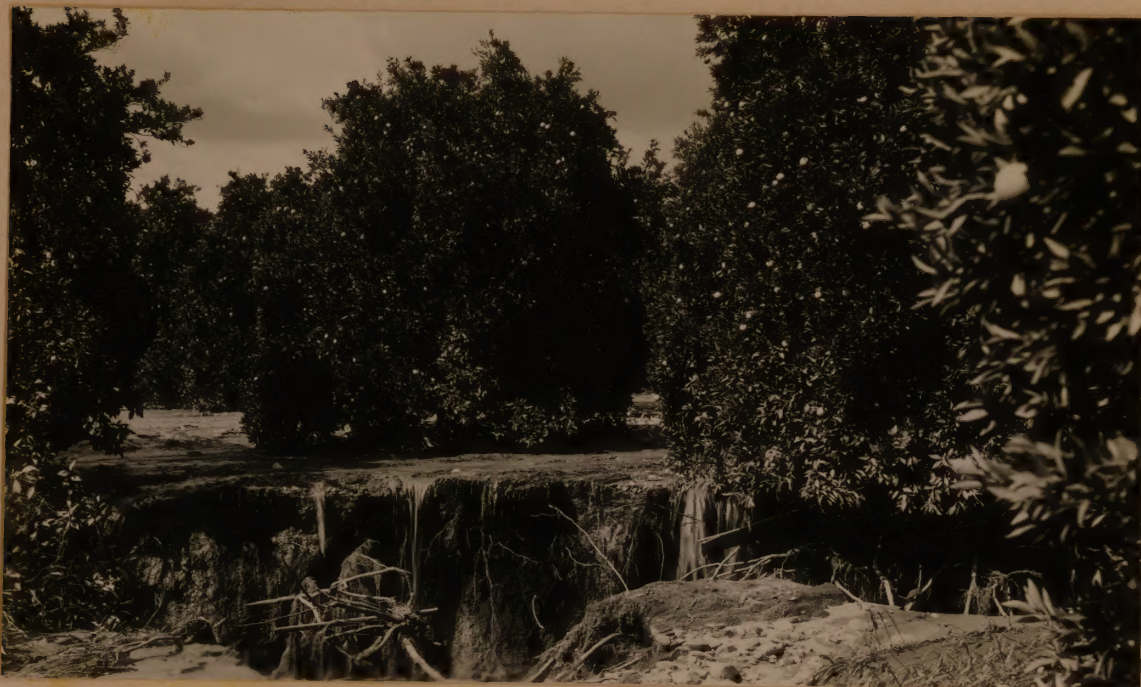
3-3-38 Bur. Ag. Eng. F&H-T1  
A. Typical gullying of orange grove high on the valley alluvial fan by San Antonio Wash, near Claremont.

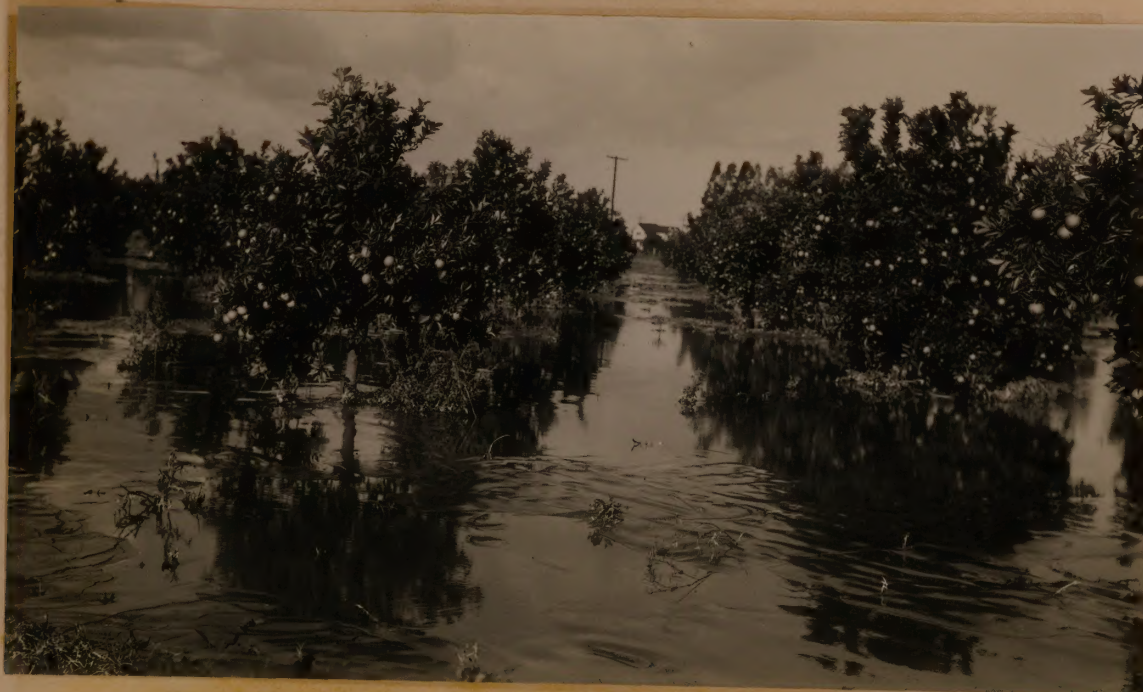
3-4-38 Bur. Ag. Eng. F&H-T2  
B. Nearer the ocean, groves suffered through deposition of fine sediments transported by flood waters from agricultural areas and mountains of the upper watershed. Garden Grove region, Santa Ana drainage.

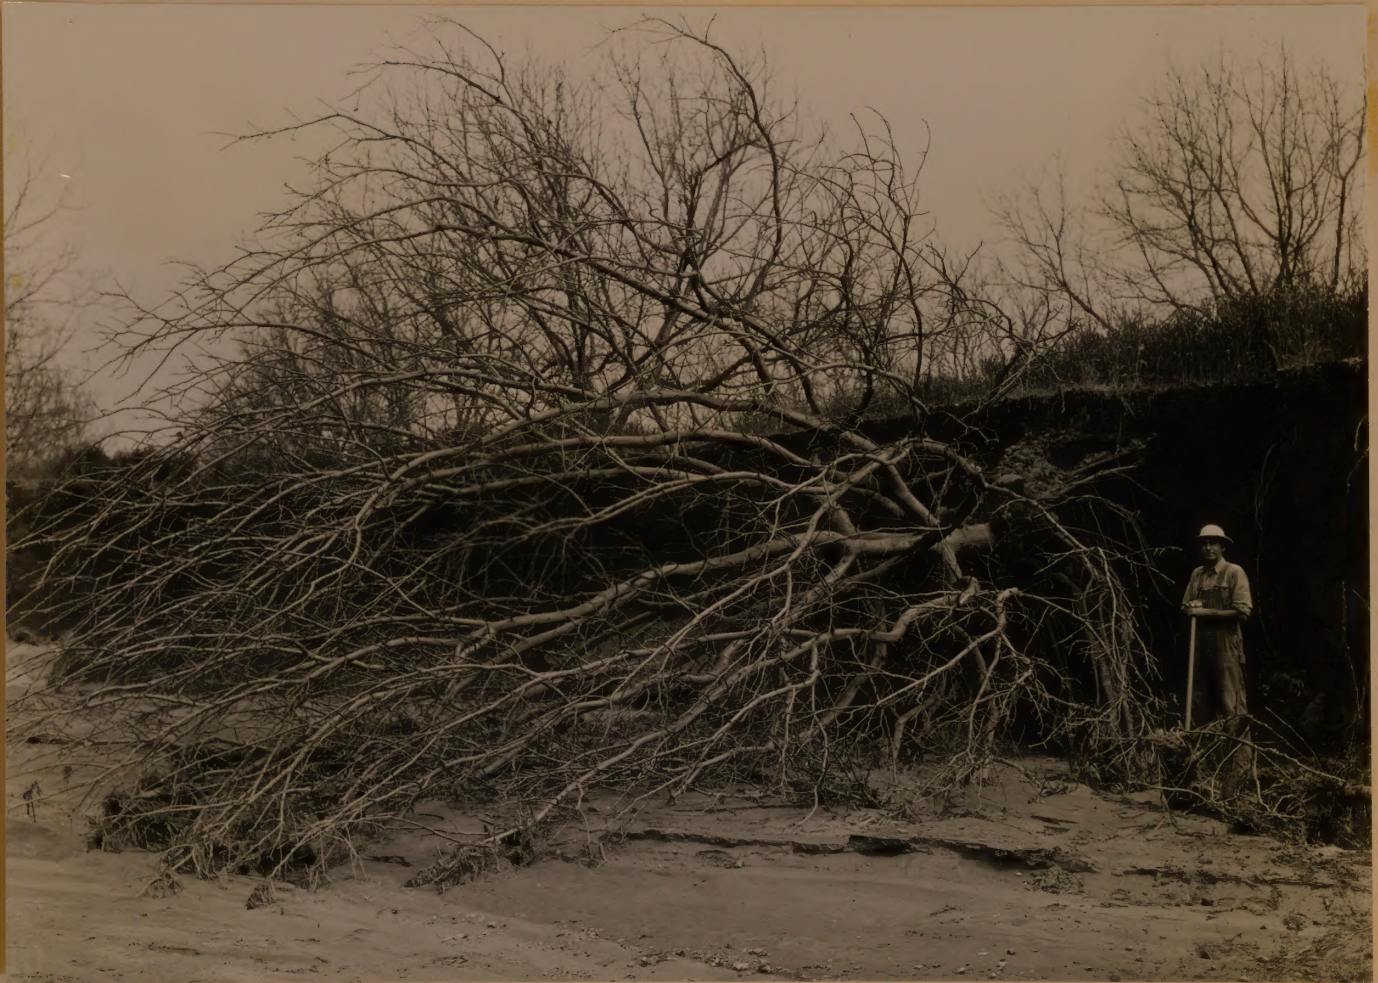
Bur. Ag. Eng. DNB-T1

Walnut orchard gullied 10 feet deep by overflow waters of lower San Antonio Creek, Santa Ana watershed. Shows serious erosion of deep soils in the highly valuable lower valley regions.

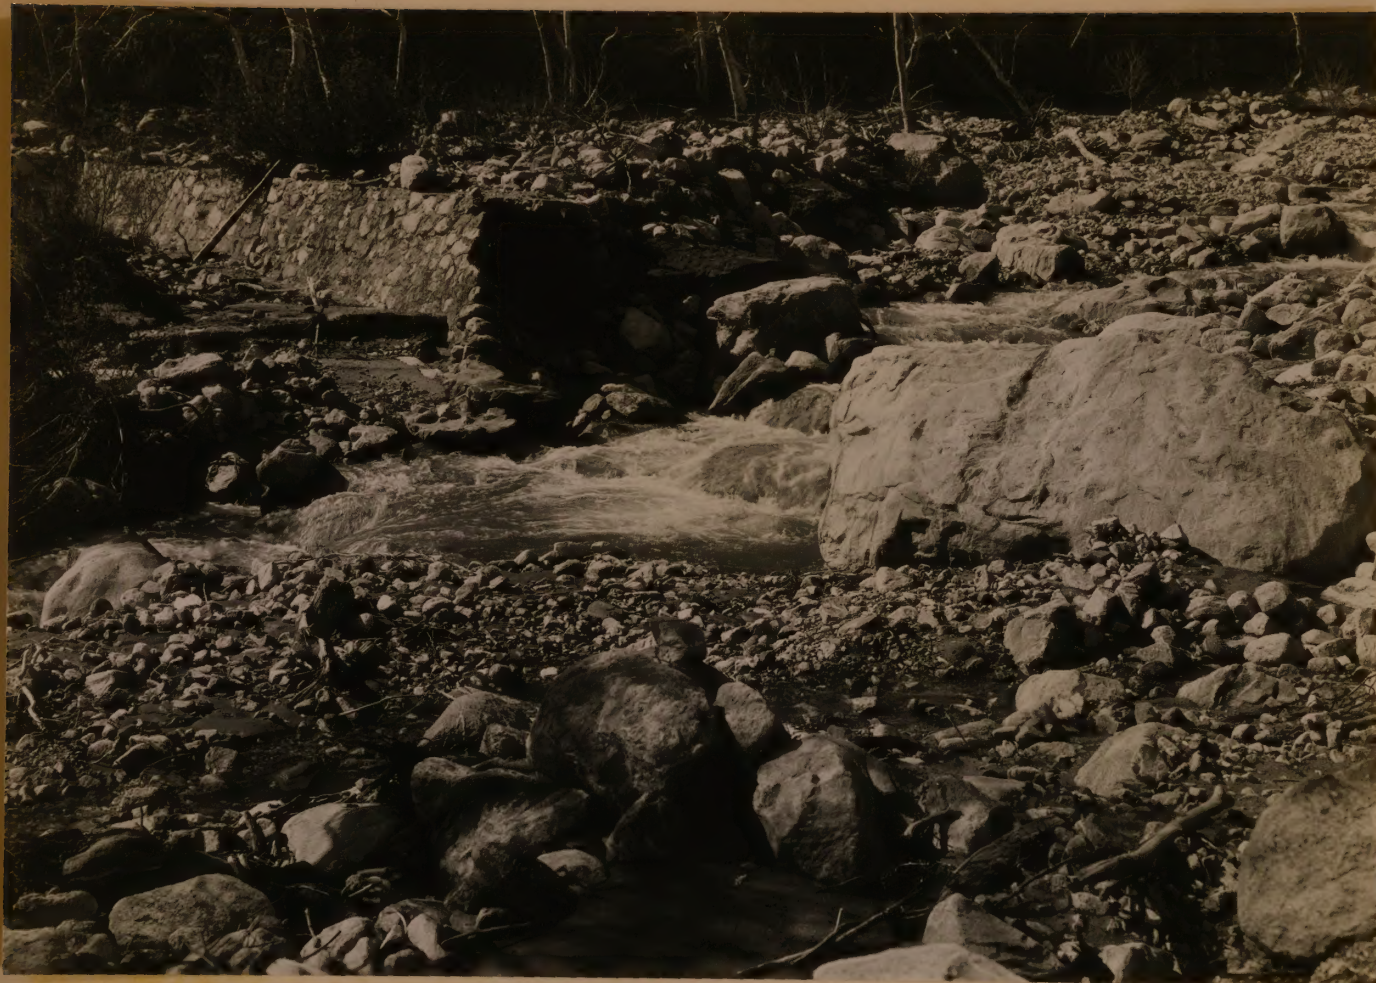
Bur. Ag. Eng. DWB-T4

Earth fill, rubble-masonry surfaced check dam five feet high, that was broken through by flood-borne boulders. Such construction can not withstand the battering of torrent-carried debris. West Fork Devil Canyon, Santa Ana watershed.

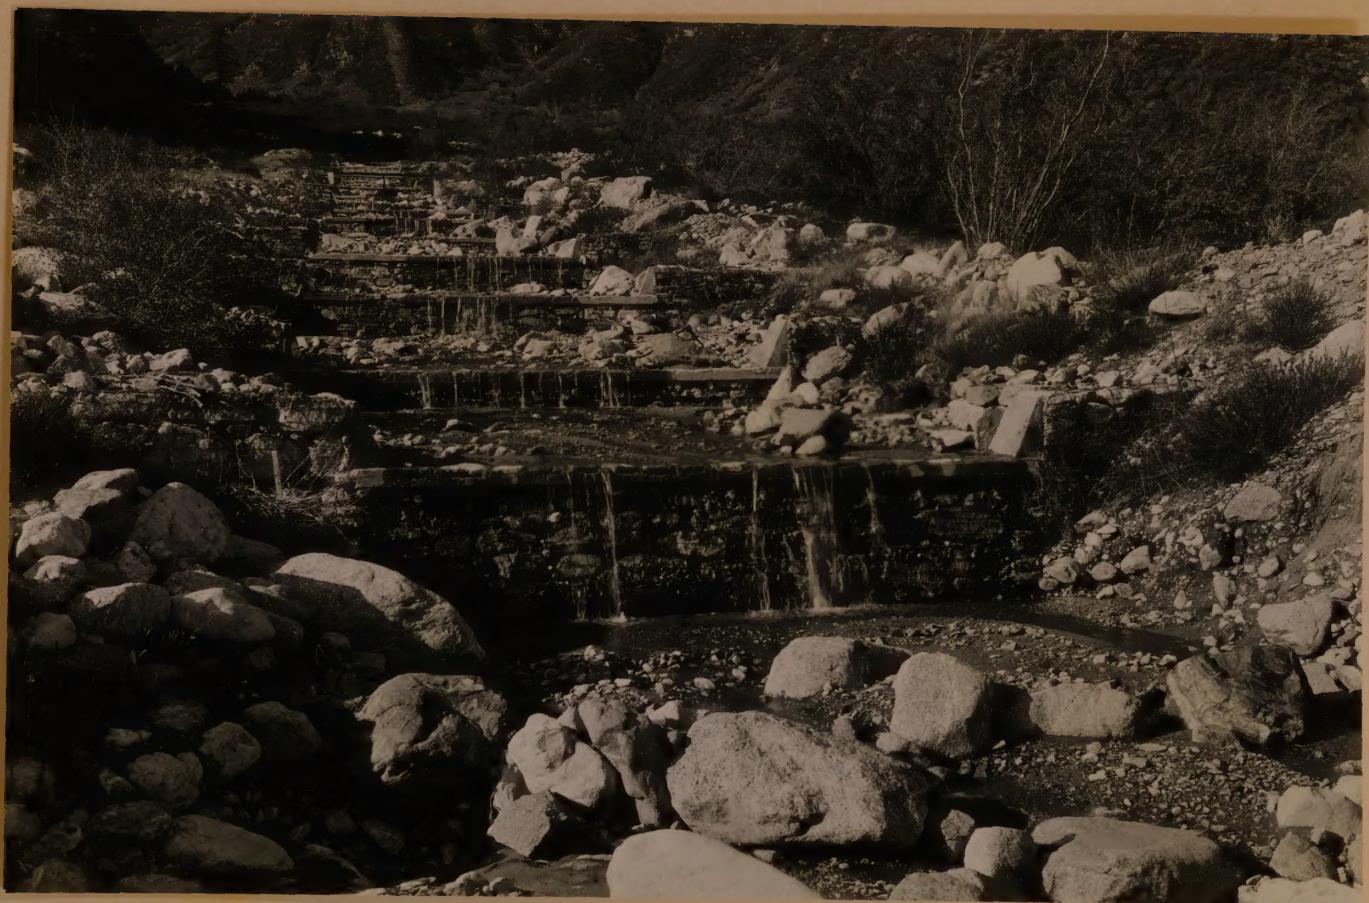
Bar. Ag. Eng. DHB-T5

Dams of solid rubble-masonry, with concrete spillways, closely spaced along channel, successfully withstood the battering of March 2 flood. Deer Creek spreading grounds, Santa Ana watershed.

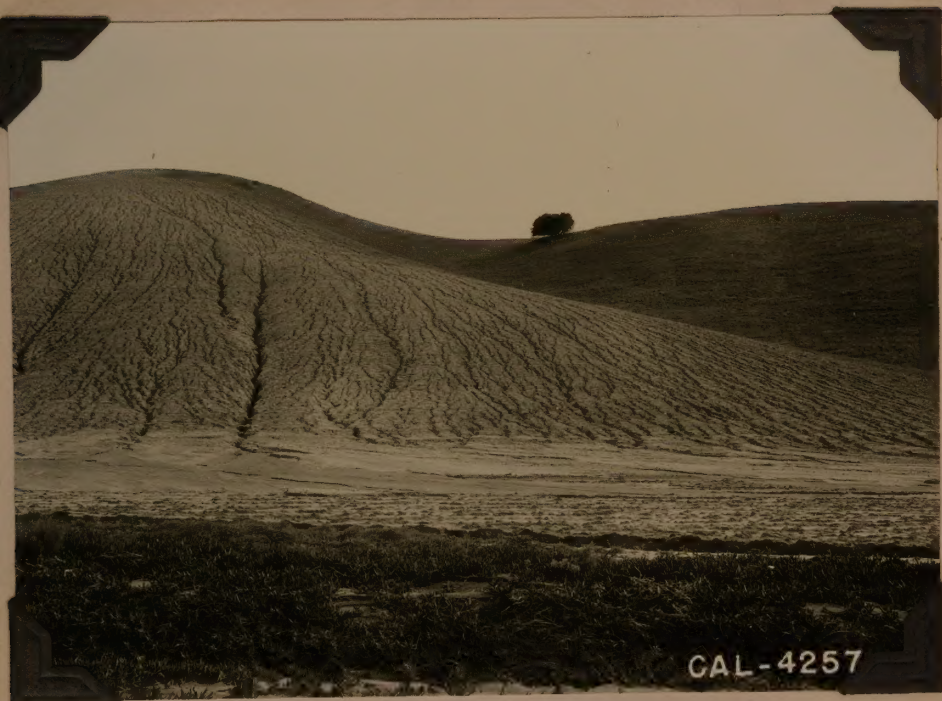
Glenn Property

Striking example of clean-cultivated land continuously farmed to beans year after year. Shows comparison between the hill in the foreground which was clean-cultivated and the hill in the background which had been retired for two years, 1935 and 1936.

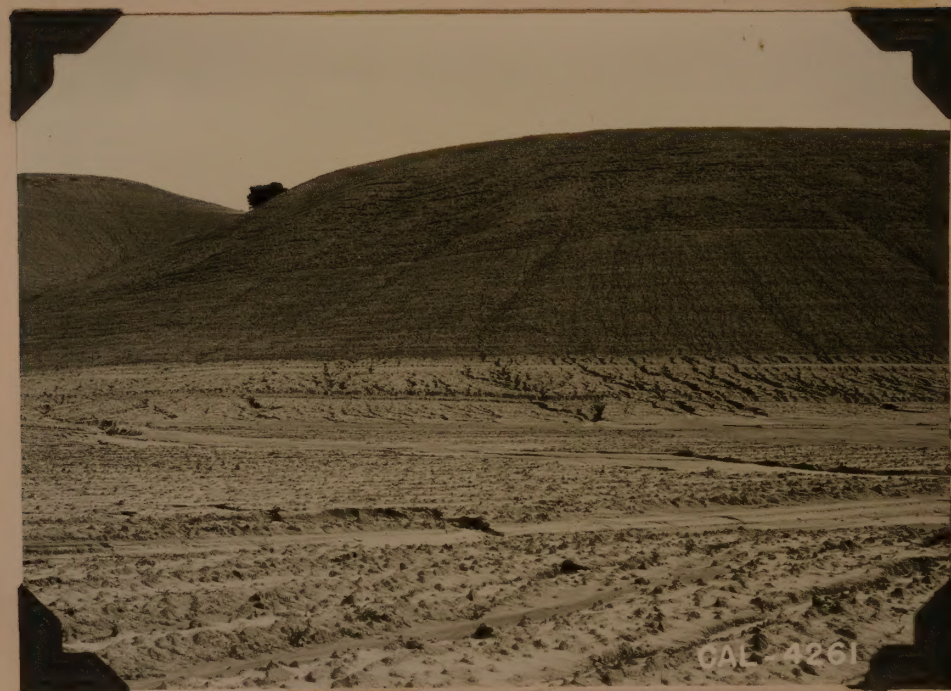
Glenn Property

Outstanding example of different degrees of erosion caused by different farming practices. Light, lower portion of photograph is of fairly level ground which has been continuously farmed to beans without crop rotations or without giving the land a rest. Upper half, or shaded portion, is of the hill shown in the background of the adjacent photograph and which had been retired during 1935 and 1936. All of the land was farmed to beans in 1937, and on March 10 when this photograph was taken, the upper half of the hill had been cultivated once, the lower half twice, and the bottom or light portion, four times. This gives a striking example of the damage or protection obtained by different cultivation practices.

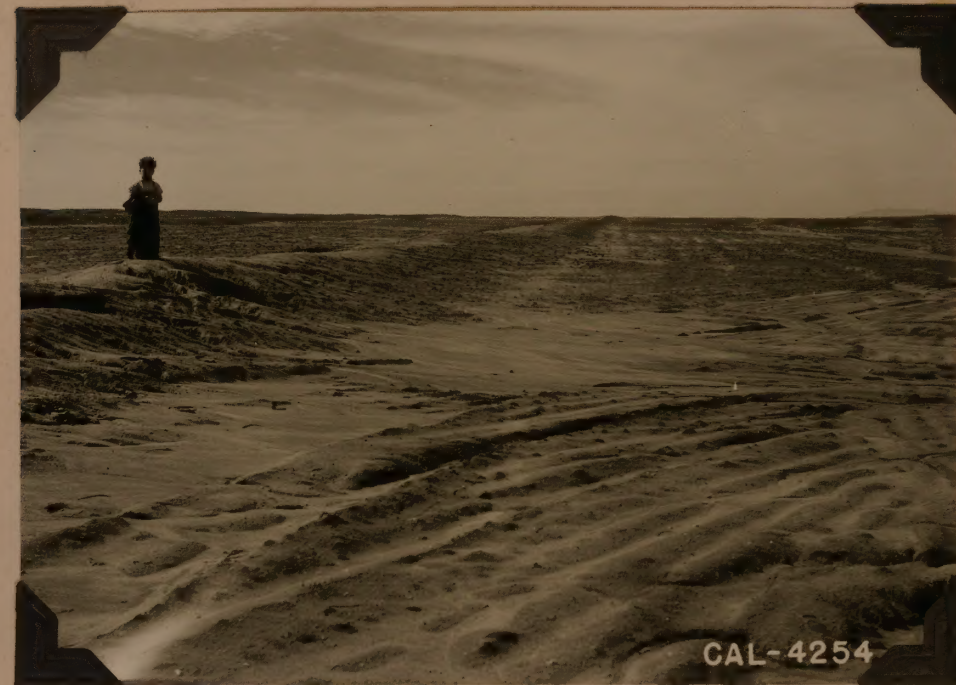
CAL-4254

This property is adjacent to the Arneill property on the West. Identical as to size, slope and soils. Planted to winter flax the same week as the Arneill property. This property controlled by broad-base terraces. Very little damage to terraces. Minor soil losses.

SOILS: Huerhuero fine sandy loam with dense clay subsoil.

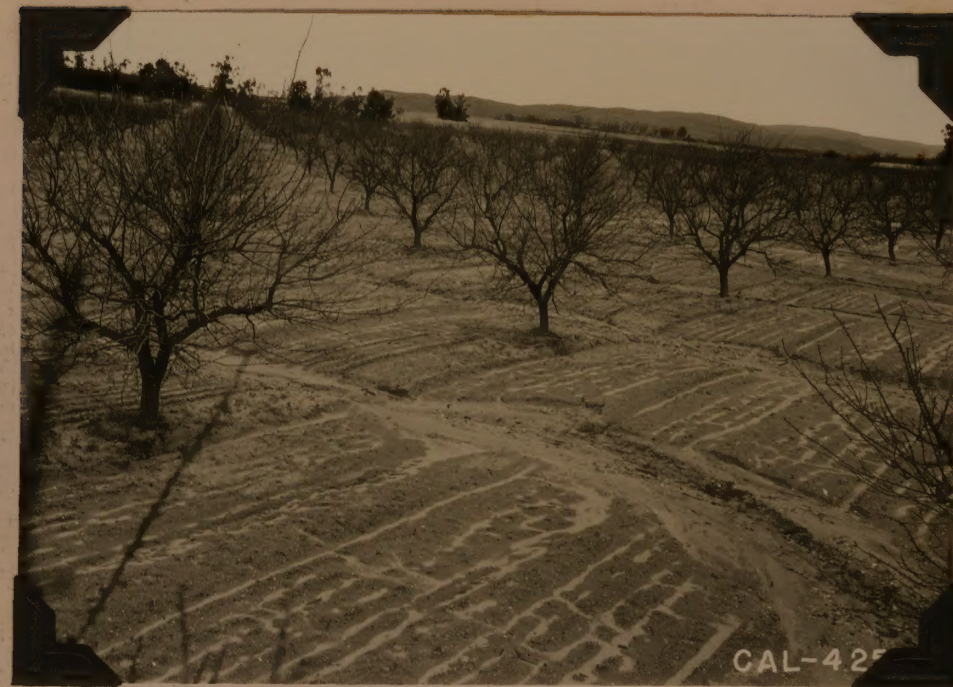
Harris Hitch Ranch

This orchard lies immediately adjacent to the Waters' property. Shows soil washes and losses where no erosion control methods have been taken. Formerly, all apricot groves in this district were farmed in this manner.

SOILS: Madera sandy loam with moderate clay sub-soil.

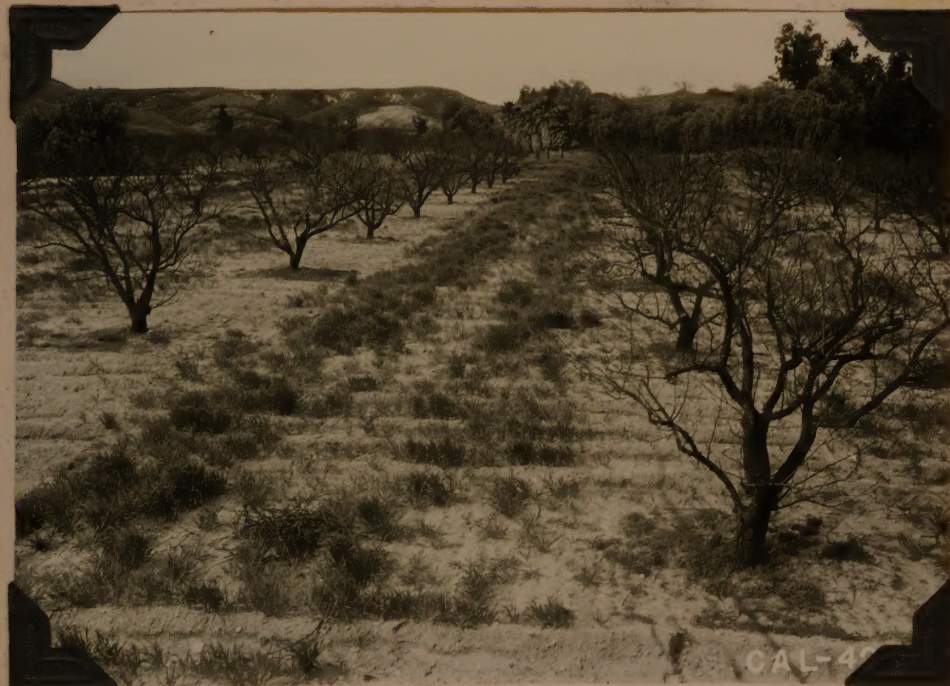
Mose Waters' Ranch

This 100-acre apricot grove is dry-farmed and prior to this year has been clean-cultivated during the winter months. Property under cooperative agreement at present and erosion being controlled with basin-listing and cover cropping. To date, 17 and 1/2 inches of rain have fallen on this orchard, including the rain of March 2.

SOILS: Yolo loamy sand to 6 feet or more.

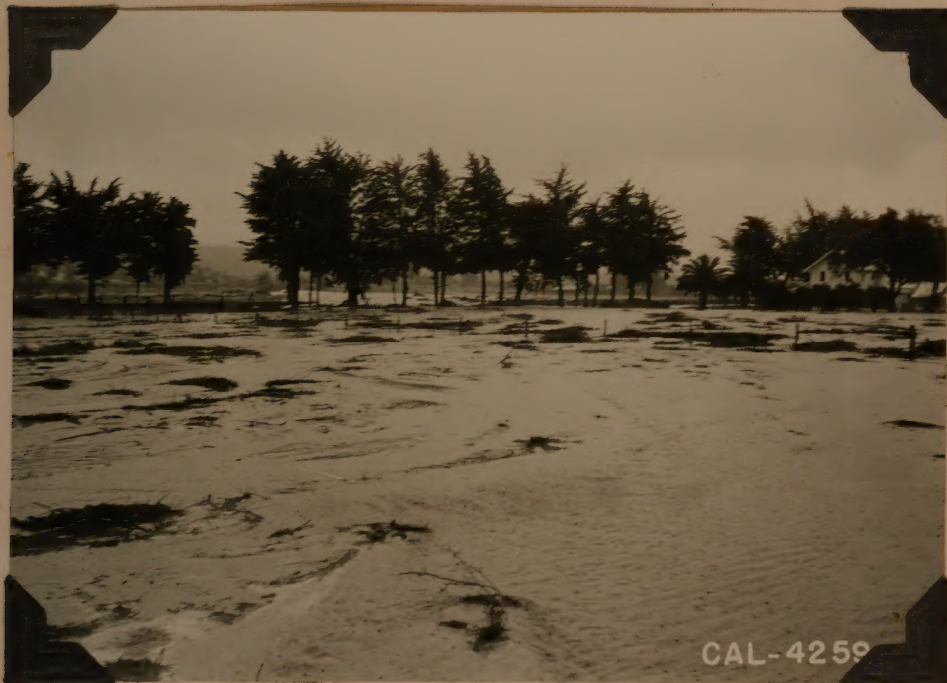
CAL-4259

View of water and sand flowing across a ranch, off the Las Posas Area, during the storm of March 2nd. This picture was taken from a wagon standing in the field. Later, the wagon was nearly covered with silt and debris from the water flowing in the foreground.

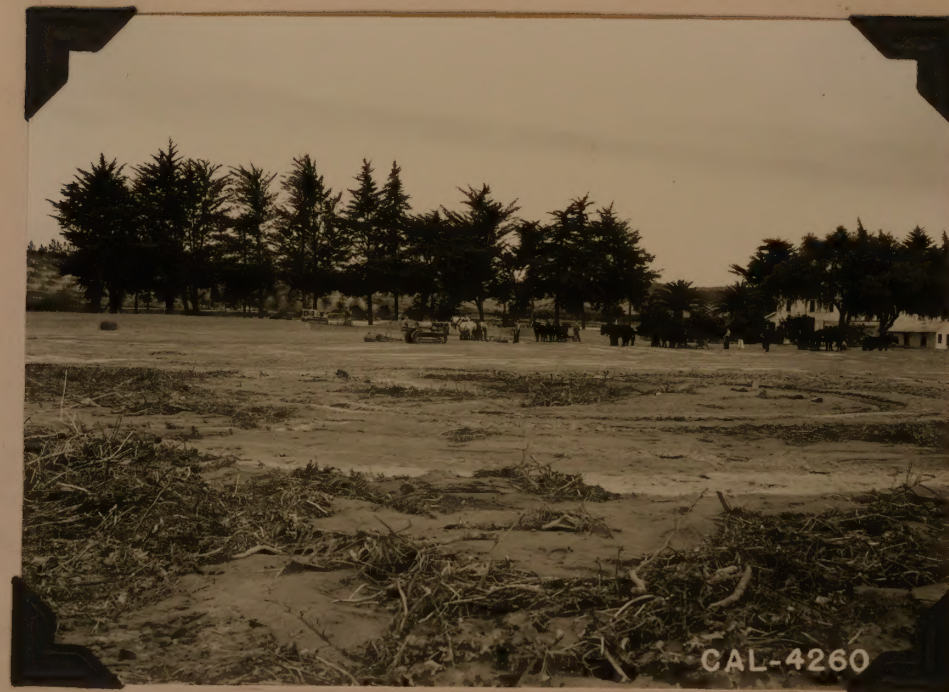
CAL-4260

Same view as adjoining picture but photographed on March 10th. Shows condition of field after flood waters had subsided. Beginning April 1, this field is to be planted to Valencia oranges. Owner estimates cost of removing sand from field at \$250 an acre. Stock and equipment shown in picture are being used to clear the field and prepare it for the planting of oranges.

SOILS: Sorrento sandy loam,  
uniform to 6 feet.

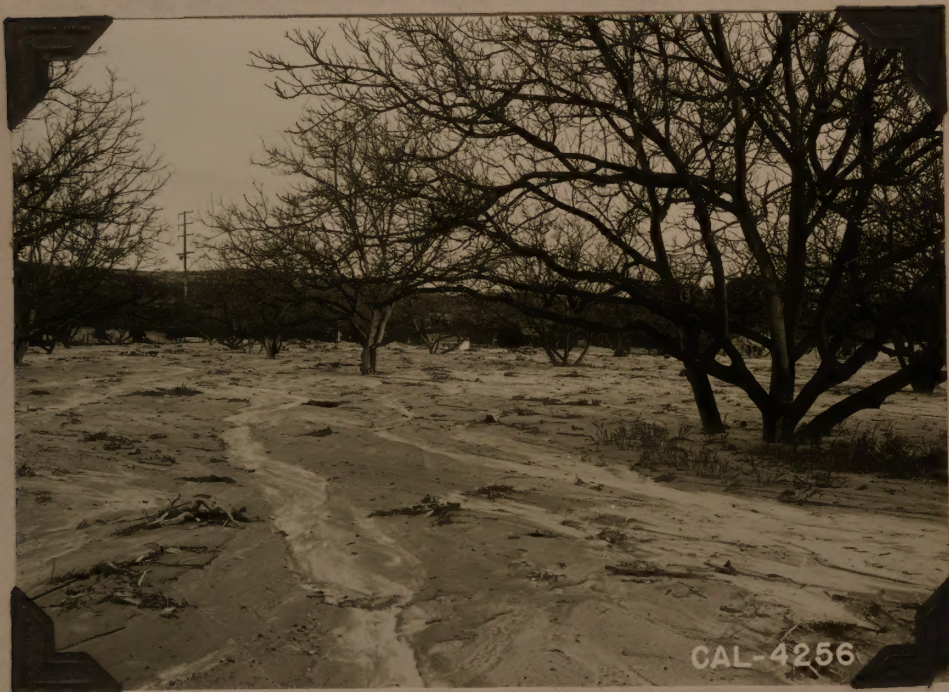
Hoffelt Property

Showing 33 year old English Walnut grove, 9 acres in area, being covered by deposition from clean-cultivated bean land two miles distant. Measurements were taken of the deposition and the average depth was estimated as 3 feet. This deposition varies from a few inches on one part of the orchard to as much as six feet in the deepest parts. Owner considers both orchard and land a total loss.

SOILS: Yolo sandy loam

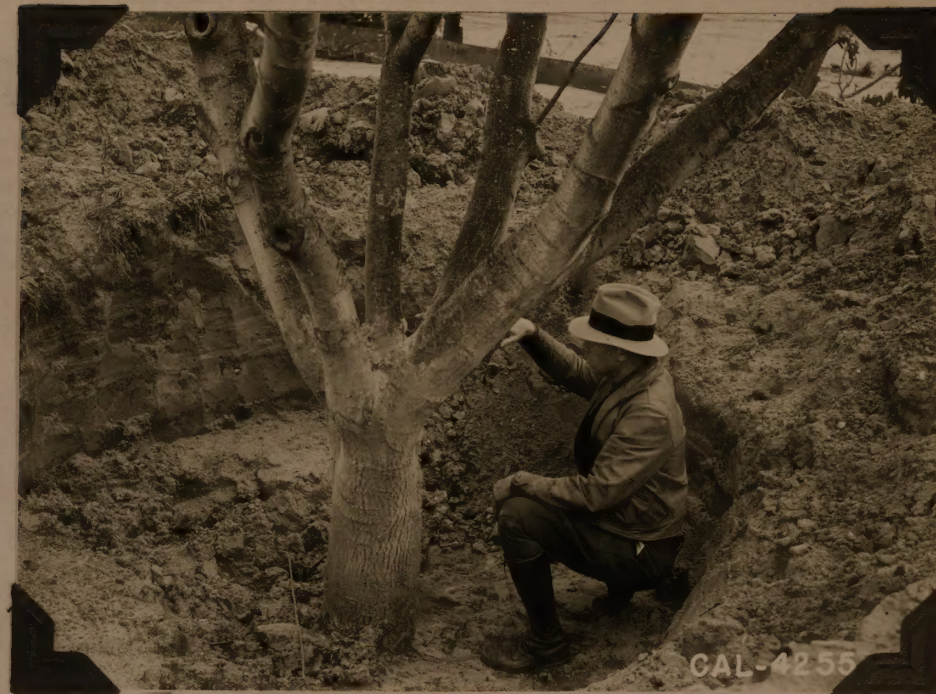
Hoffelt Property

Showing depth of deposition around 33 year old English Walnut tree. Banks of excavation are of pure sand with no agricultural qualities whatever.
